FAA Approved
Airplane Flight Manual Supplement
For
Cirrus Design Corporation Model SR20/SR22
and SR22 when modified per STC SA10588SC
(Tornado Alley turbo-normalizer)
with
Avidyne DFC90 Digital Flight Control System p/n 700-00170-000

Page 1 of 44
P/N 600-00249-000
Rev 03

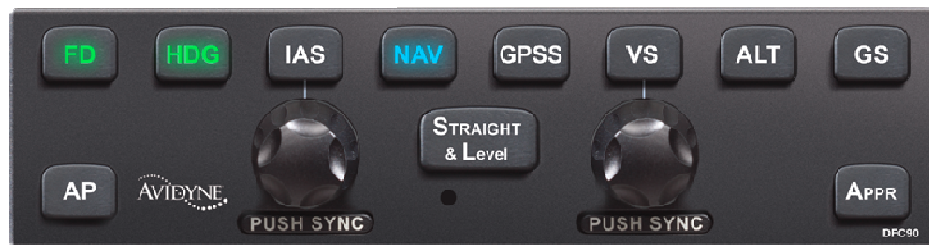
Figure 1 – DFC90 Autopilot Control Panel

Figure 1 depicts the Avidyne 700-00170-000 DFC90 Autopilot Control Panel.

Each DFC90 autopilot contains an internal data recorder for use during service operations. If an anomalous behavior is observed with the autopilot, pressing the “GS” button on the autopilot control panel will act as an event marker to identify an event or a series of events in the data log that will aid the Avidyne Service Center in finding and analyzing the data logs during troubleshooting operations.

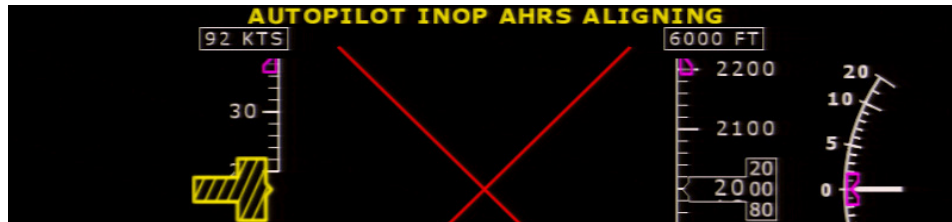
PFD Autopilot Annunciator

Autopilot failures that prevent any operation are annunciated across the center of the PFD mode annunciator strip in amber (yellow) as shown in the example immediately below.

If the turn coordinator is failed upon initial power-up, the autopilot will be prevented from engaging in any mode. This special case is indicated by a yellow “AUTOPILOT INOP TURN COORDINATOR FAIL” message in the center of the PFD autopilot mode annunciator area.

A failure of an AHRS is identified by Red-Xs over the attitude and HSI compass card. Additionally, a yellow “AUTOPILOT INOP AHRS FAIL” message is displayed in the center of the autopilot mode annunciator area on the PFD. AP disconnect aural tones will be heard.
